Photo 1 – Ryan Farm (Howrigan & Sons), 1012 South Rd., Fairfield, VT – 08/02/16  
Concrete heifer barnyard.

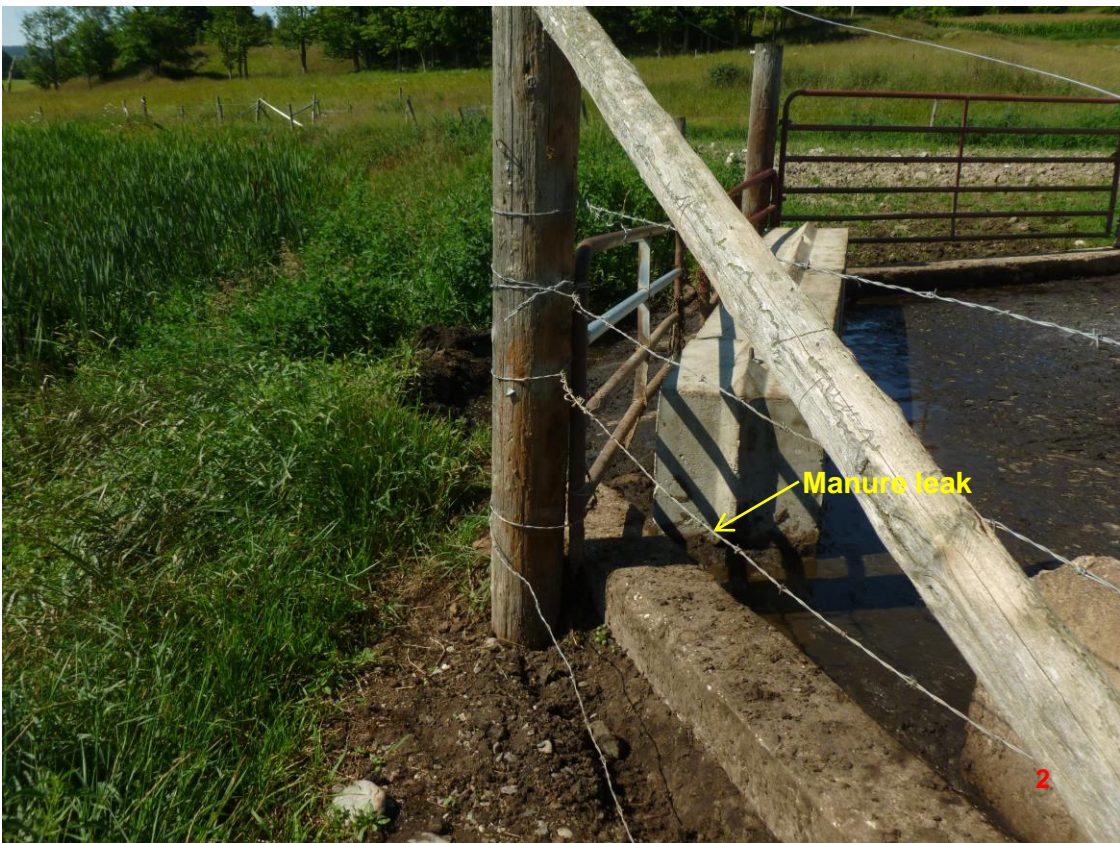
Photo 2 – Ryan Farm (Howrigan & Sons), 1012 South Rd., Fairfield, VT – 08/02/16  
Location where manure leaks from the concrete heifer barnyard.

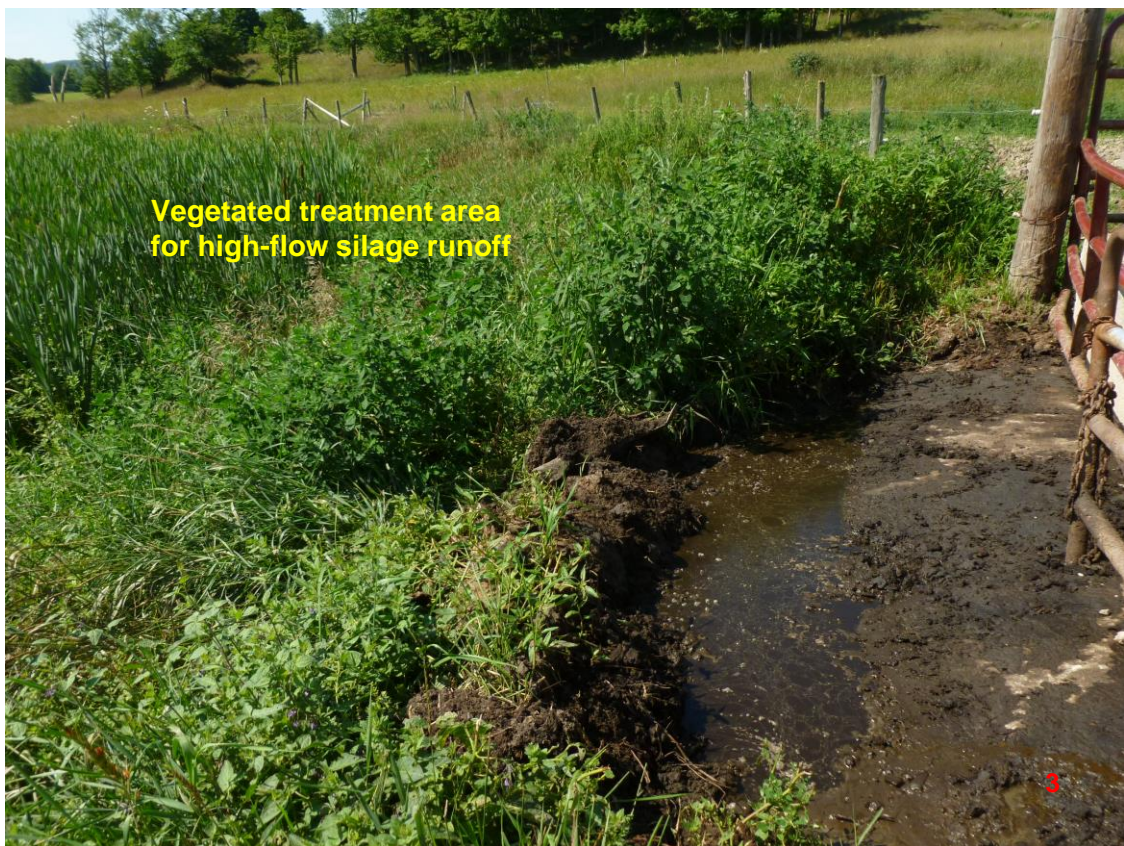
Photo 3 – Ryan Farm (Howrigan & Sons), 1012 South Rd., Fairfield, VT – 08/02/16  
Manure solids and liquid from the heifer barnyard in the silage collection system VTA.

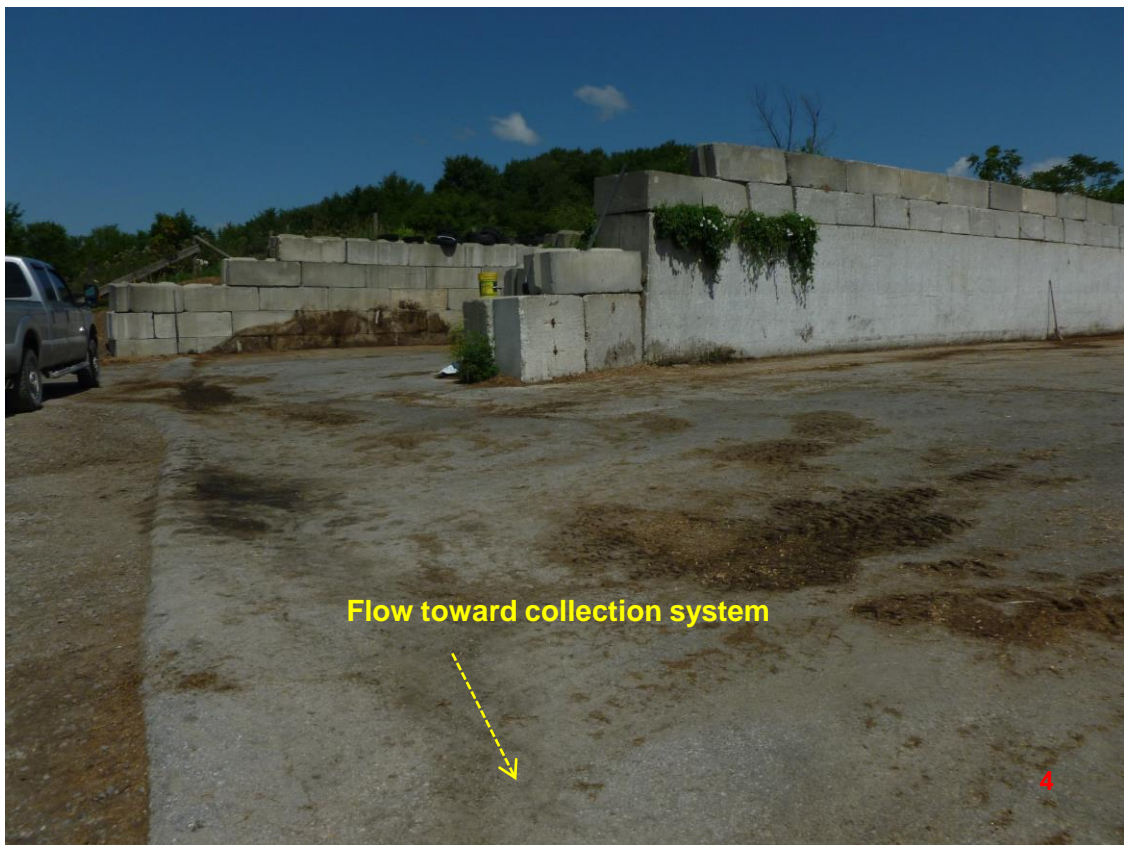
Photo 4 – Sheldon Farm (Howrigan & Sons), 429 Northrop Rd., Sheldon, VT – 08/02/16  
Silage bunkers at Sheldon Farm.

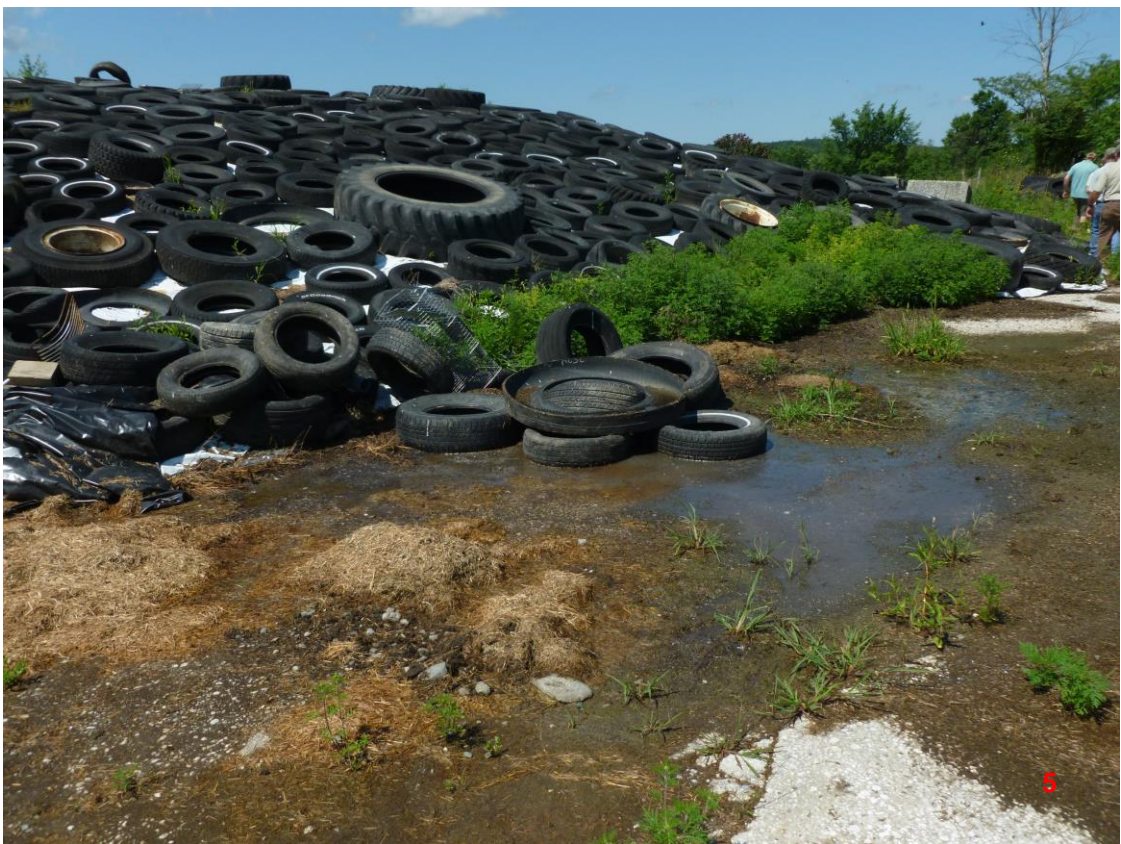
Photo 5 – Sheldon Farm (Howrigan & Sons), 429 Northrop Rd., Sheldon, VT – 08/02/16  
Leachate pooled on the back side of the silage piles.

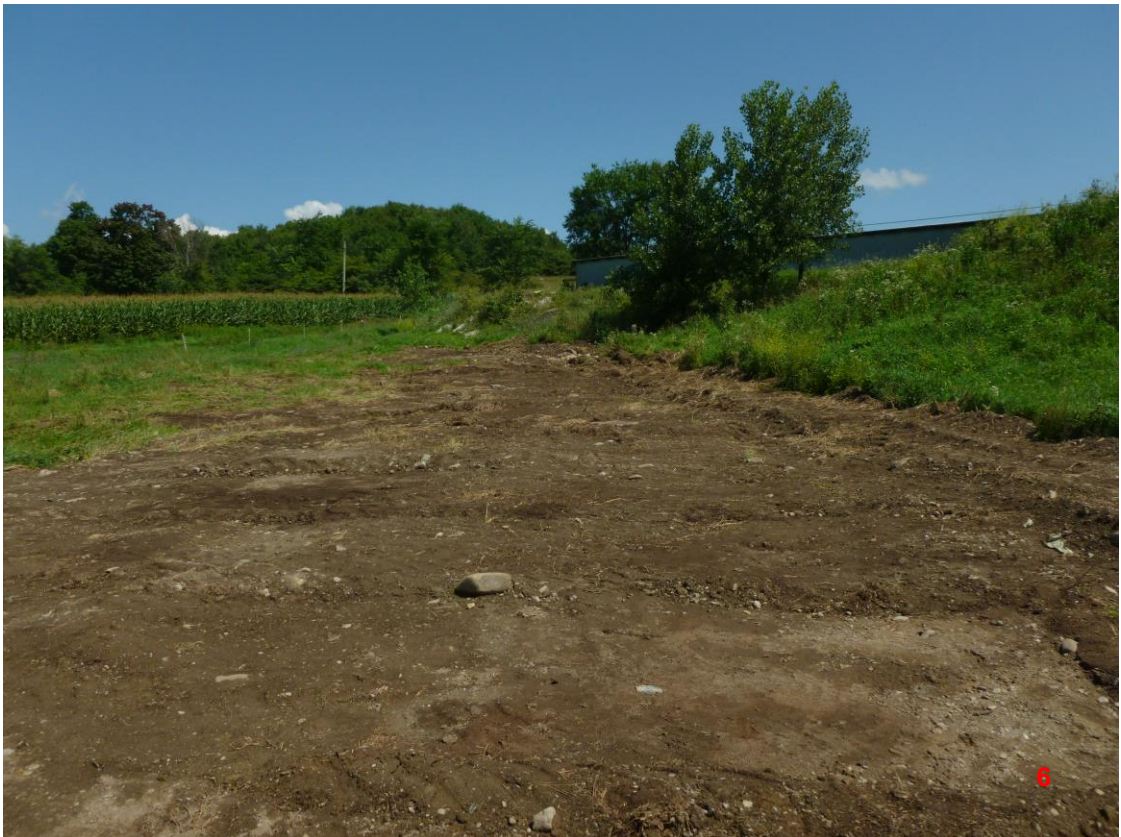
Photo 6 – Sheldon Farm (Howrigan & Sons), 429 Northrop Rd., Sheldon, VT – 08/02/16  
Open dirt lot (formerly a ditch) which receives high flow runoff from the silage collection system.

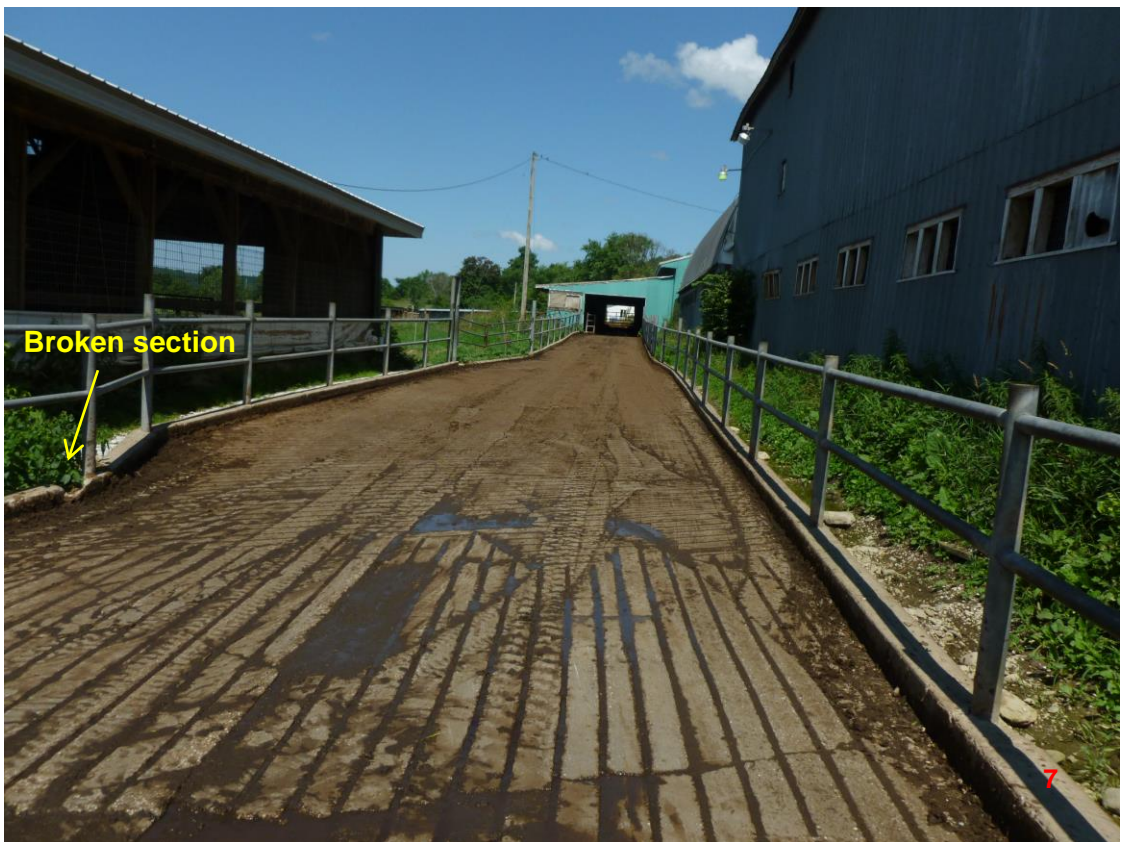
Photo 7 – Sheldon Farm (Howrigan & Sons), 429 Northrop Rd., Sheldon, VT – 08/02/16  
Concrete walkway for milking cows.

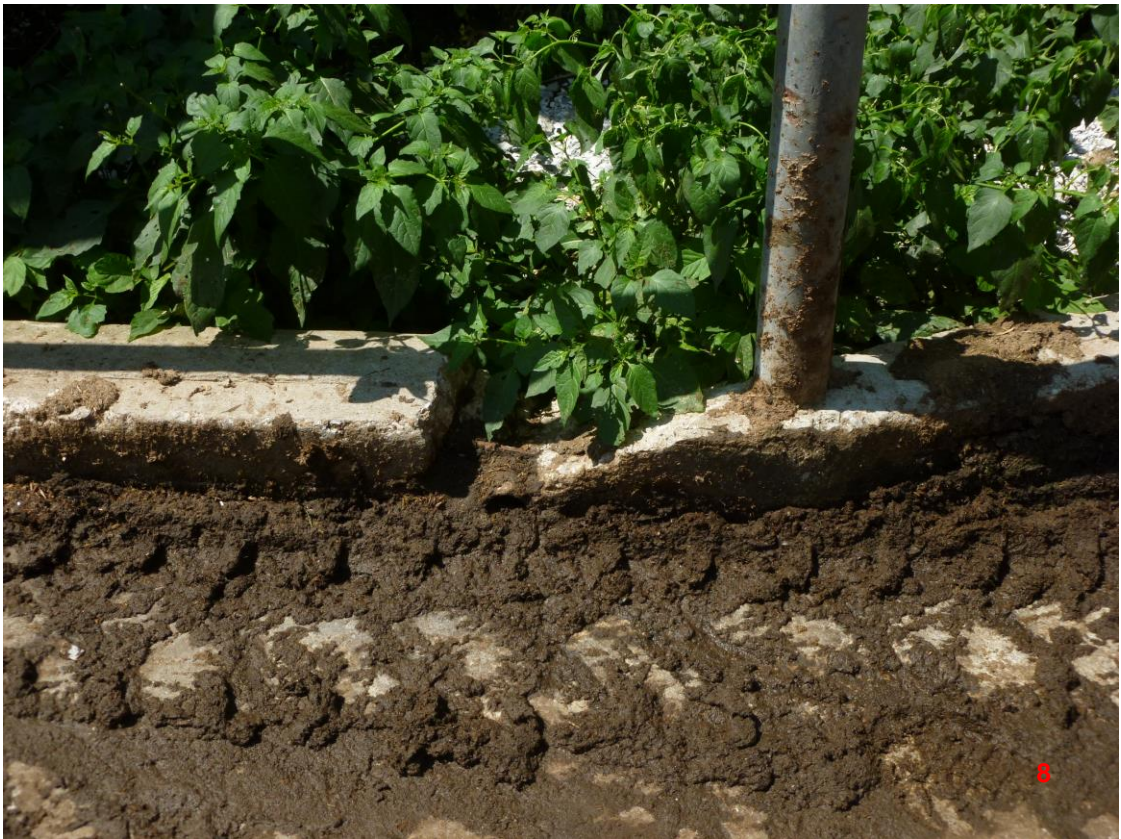
Photo 8 – Sheldon Farm (Howrigan & Sons), 429 Northrop Rd., Sheldon, VT – 08/02/16  
Manure seeping through a break in the concrete walkway curbing.

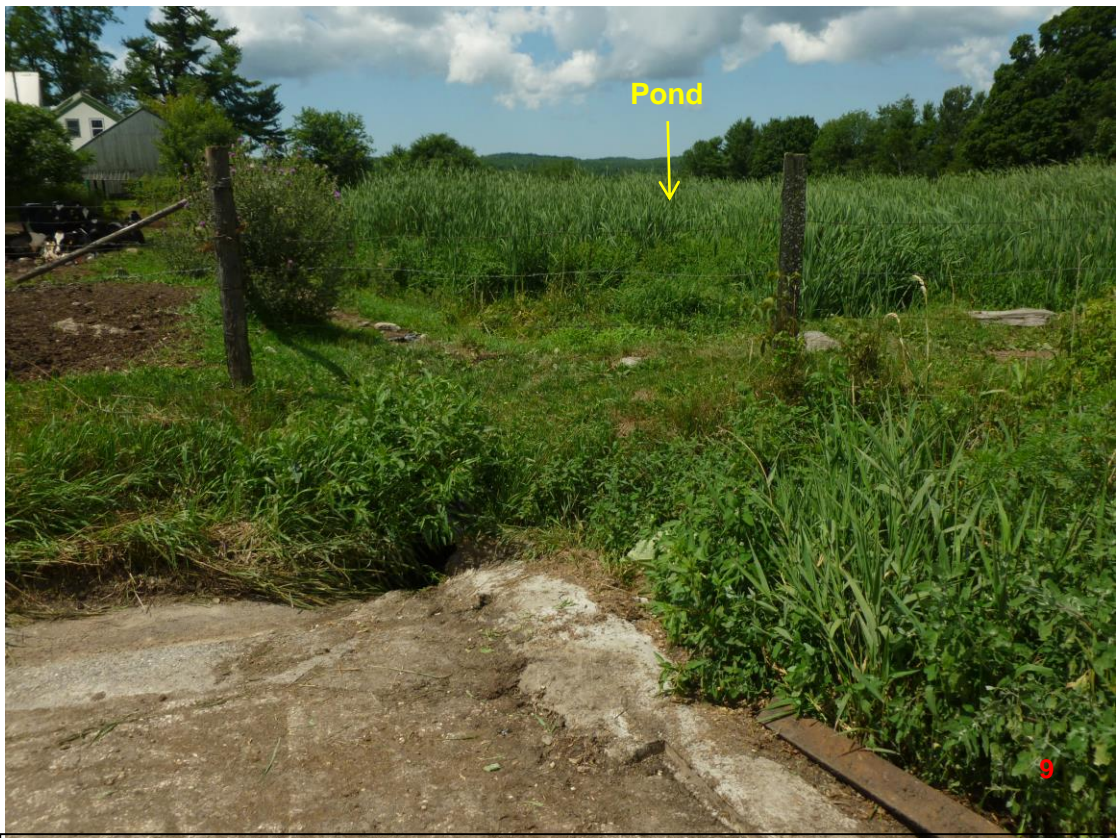
Photo 9 – Home Farm (Howrigan & Sons), 104 Rd., Sheldon, VT – 08/02/16  
Location where silage runoff is directed into a storage pond.
